**CUYAMA VALLEY  
GROUNDWATER  
BASIN –  
GROUNDWATER  
INVESTIGATION  
REPORT FOR THE  
SANTA BARBARA  
CANYON FAULT  
AND RUSSELL  
FAULT**

0011078.01  
**Cuyama Basin  
Groundwater  
Sustainability Agency**  
May 2025

**Cuyama Valley Groundwater Basin  
Groundwater Investigation Report for the Santa  
Barbara Canyon Fault and Russell Fault**

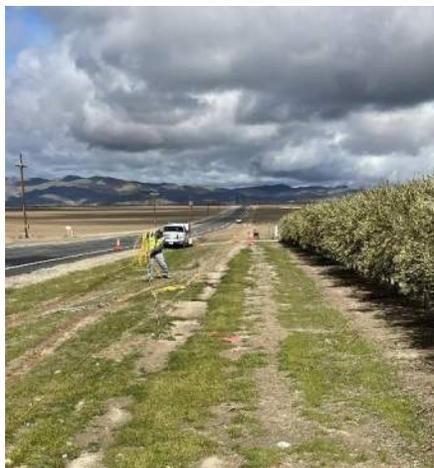
The geophysical survey of the SBC Fault was conducted on February 12 to 16, 2024. The transects shown in **Figure 3-1** could not be oriented perpendicularly to the inferred location of the fault due to land access constraints. Line 1 was 1,110 meters (3,642 feet) in ground length and trended south-southeast to north-northwest in the public ROW along the east side of Highway 33. The location of Line 1 was intended to verify the eastern bend and extent of the SBC Fault inferred by the USGS. Line 1 also overlapped with the location of deep nested wells 915-916. The overlap allowed a direct correlation of resistivity data measured to a depth of 800 feet on Line 1 with resistivity data measured by geophysical logging of the 900-foot deep borehole. While Line 1 (see photograph below) was oriented somewhat oblique (not perpendicular) to the inferred trend of the SBC Fault, its orientation was considered acceptable to detect it. There is a generally

accepted window of about 40 degrees (plus or minus) perpendicular to a linear feature to detect it with a geophysical survey.

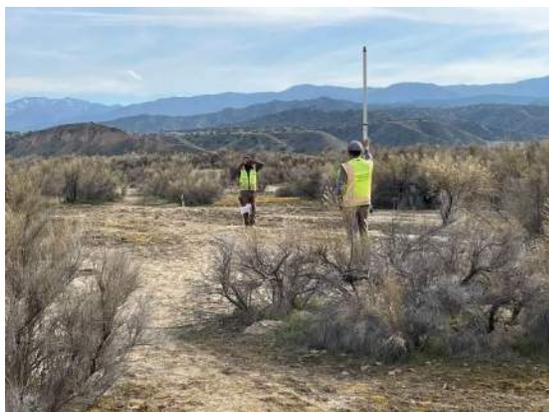
Line 2 (see photograph below) was 920 meters (3,018 feet) in ground length and trended south to north. The southern end began on the northern side of the unpaved Big Pine Road and was truncated in the Cuyama River bed before a steep embankment at the northern edge of the river. Line 2 was oriented perpendicular/sub-perpendicular and centered on the inferred location of the SBC Fault. The ground was adequately level with sparse to dense vegetation.

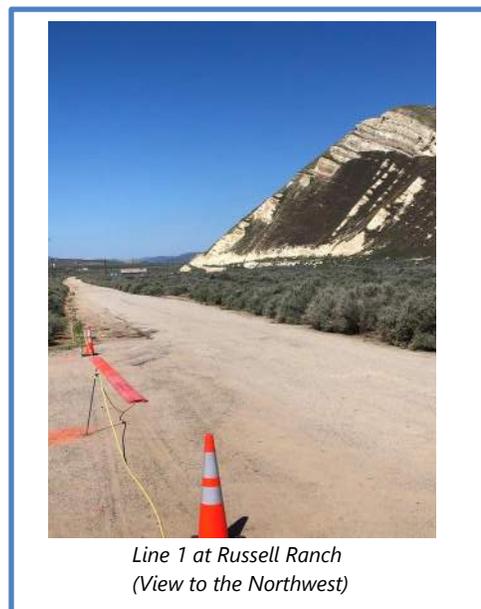
Line 1 was established adjacent to the southern edge of a generally flat unpaved road. It extended to about 330 feet northwest of an abandoned well known as "Cuyama-1" to the northwest into a vegetated area on the North Fork Ranch. Line 2 was established between 300 and 600 feet south/southwest of and subparallel to Line 1 just northeast of the Cuyama River bank through vegetated areas on both properties. It began about 350 feet southeast of Cuyama-1 and continued to the southeast of a well pad containing wells with API # 07900946 and # 07900942. Line 1 and Line 2 were 1,110 meters (3,642 feet) in ground length. Wells 900-902 are located roughly 1,500 feet east-southeast of, and about 8 feet lower in elevation, than the southeastern end of Line 1.

The Schlumberger and dipole-dipole geometrical arrays were used to collect resistivity on Line 1. Due to heavy vegetation, only the Schlumberger array was used to collect resistivity data on Line 2. IP data was not collected on Line 1 or Line 2.

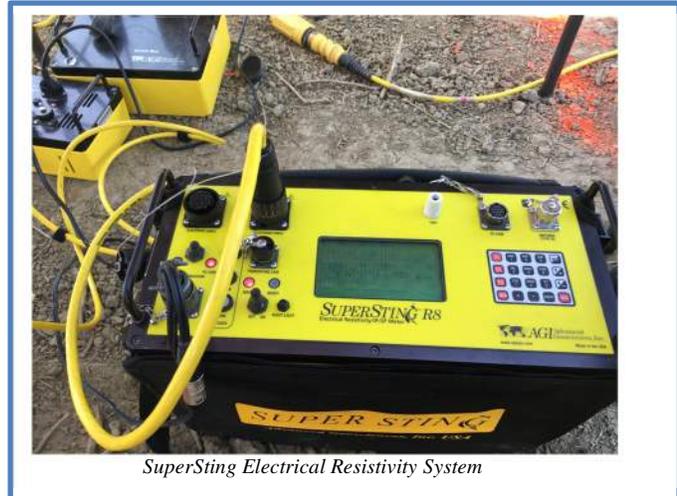
*SuperSting Electrical Resistivity System*
